120-inch Water Main Break (WMB) Conclusion for the Board

120-inch Water Main Break

Largest size transmission main in GLWA system

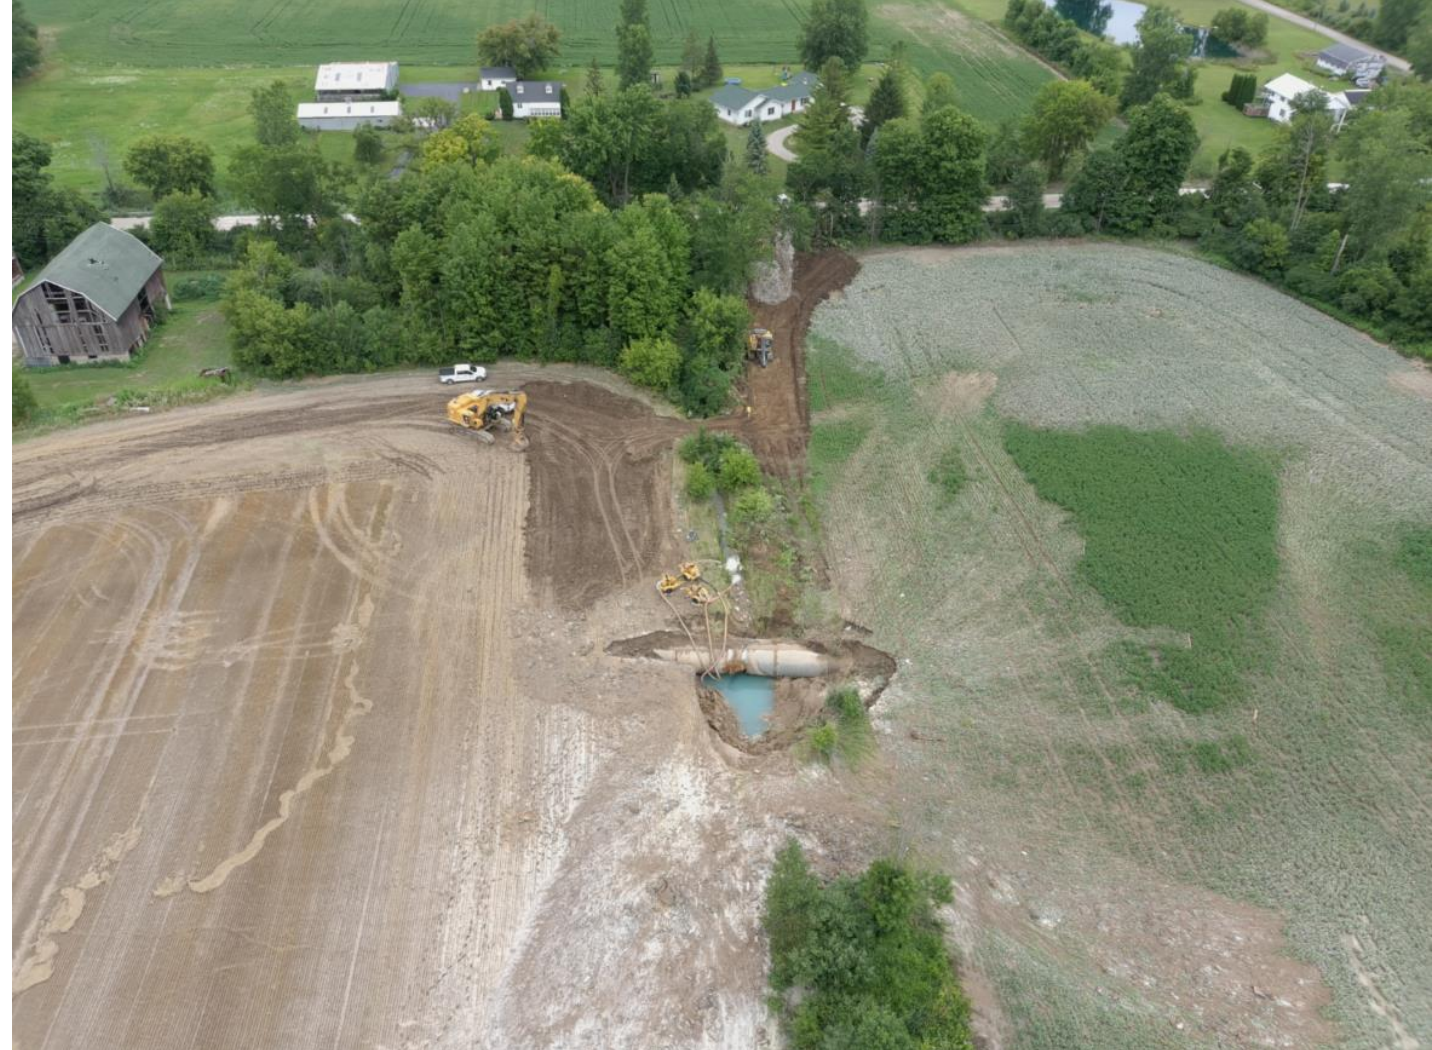
Root Cause:

- Loss of strength due to broken wire wraps damaged from corrosion and hydrogen embrittlement.
- A defect in the mortar coating developed the environmental conditions for corrosion and embrittlement.
- Lack of cover contributed to the mortar coating defect.

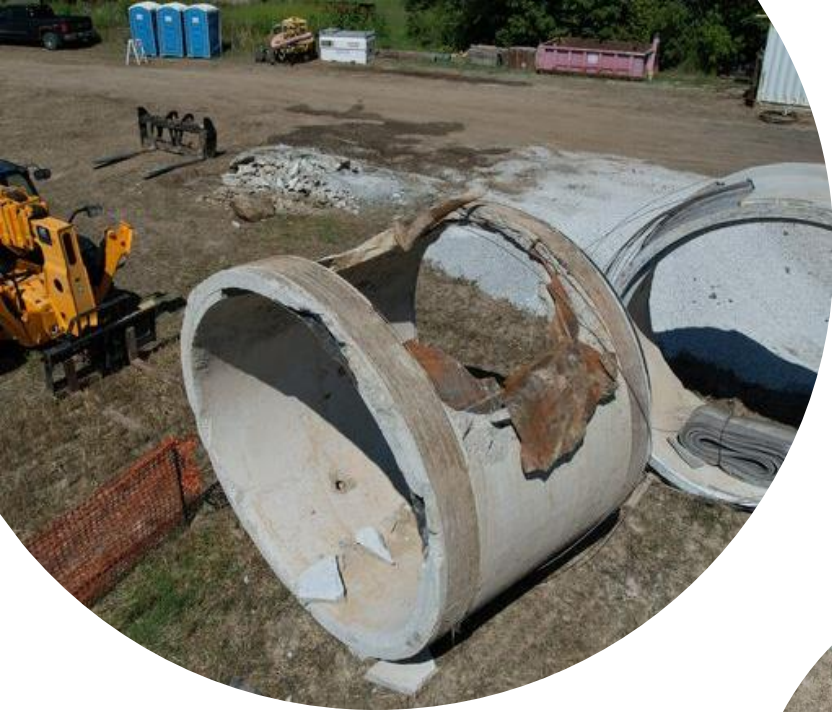
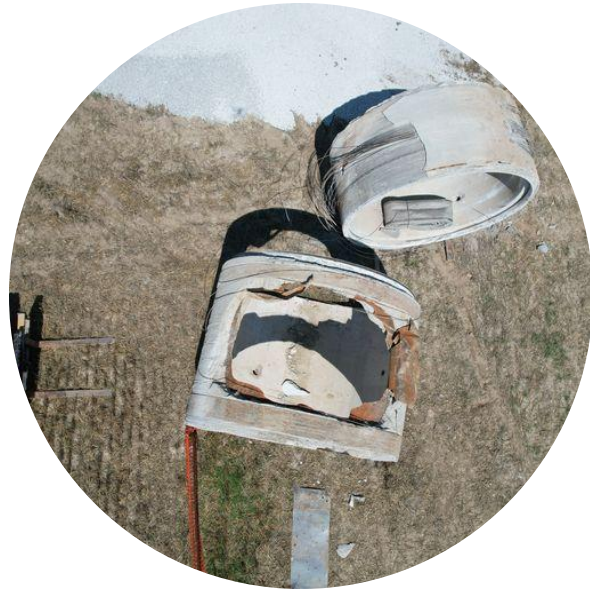
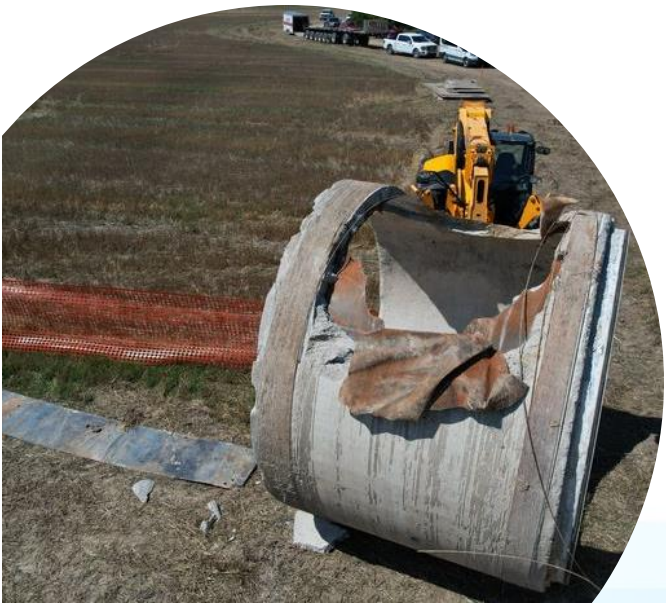
Damage Pipe Removed

Removal
of
Damaged
Pipe

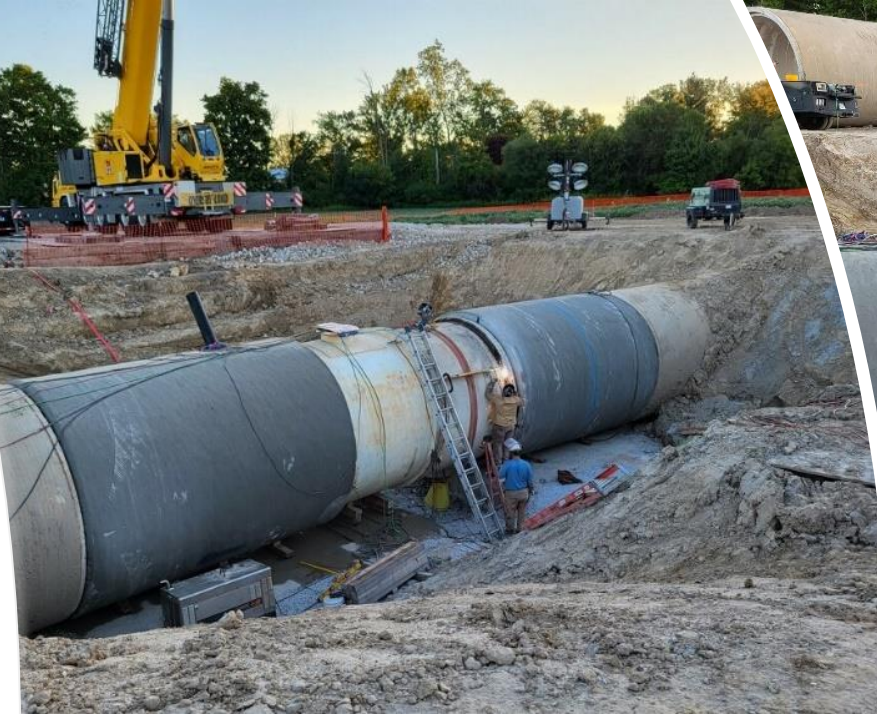
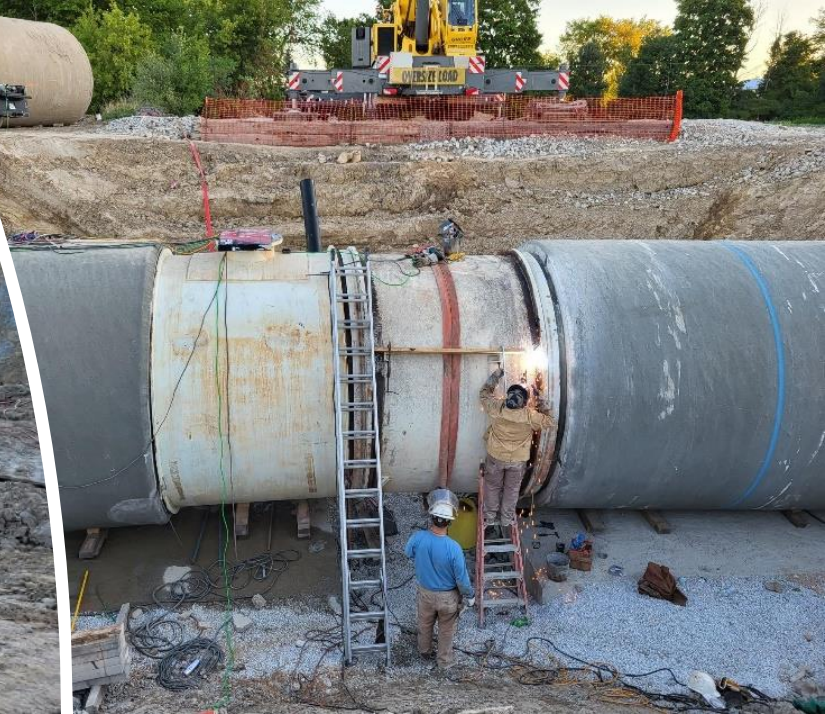
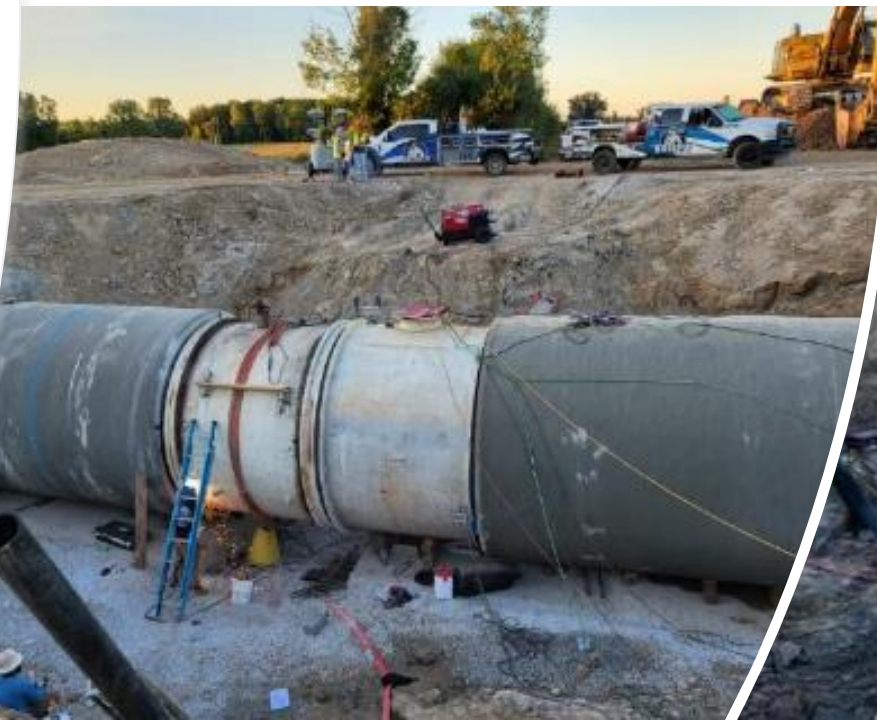
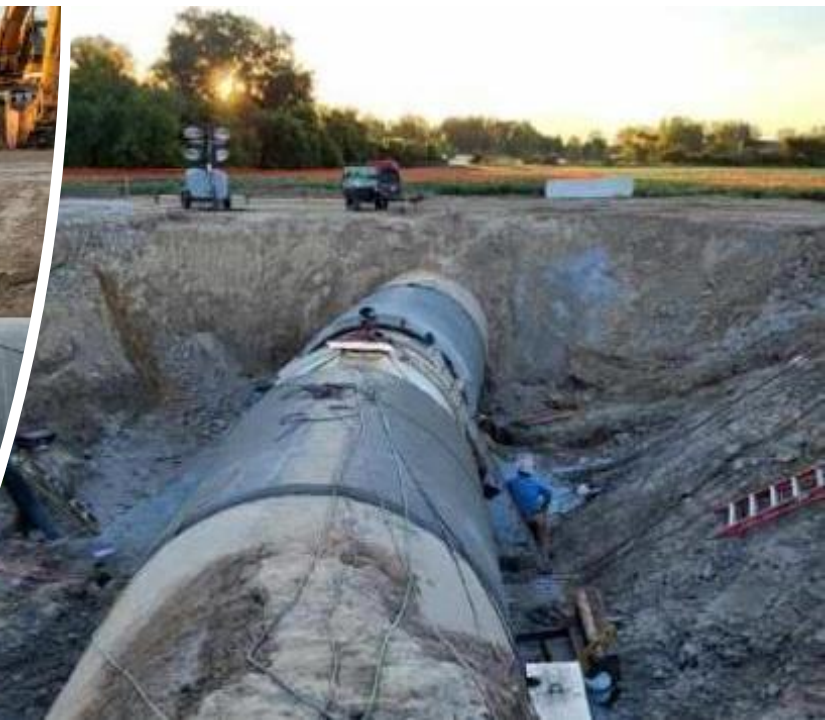
Pipe in the ground welding continues
